**Bristol-Myers Squibb Manufacturing Company**  
Rt. 3, km 77.5 Humacao, Puerto Rico 00791

## **Interim Corrective Measure Building 5 Area**

# **Soil Treatment Cell Closure Certification Report**

**Eng. Carlos A. Rivera Hernández, P.E.**  
**CAR Engineering, Inc.**

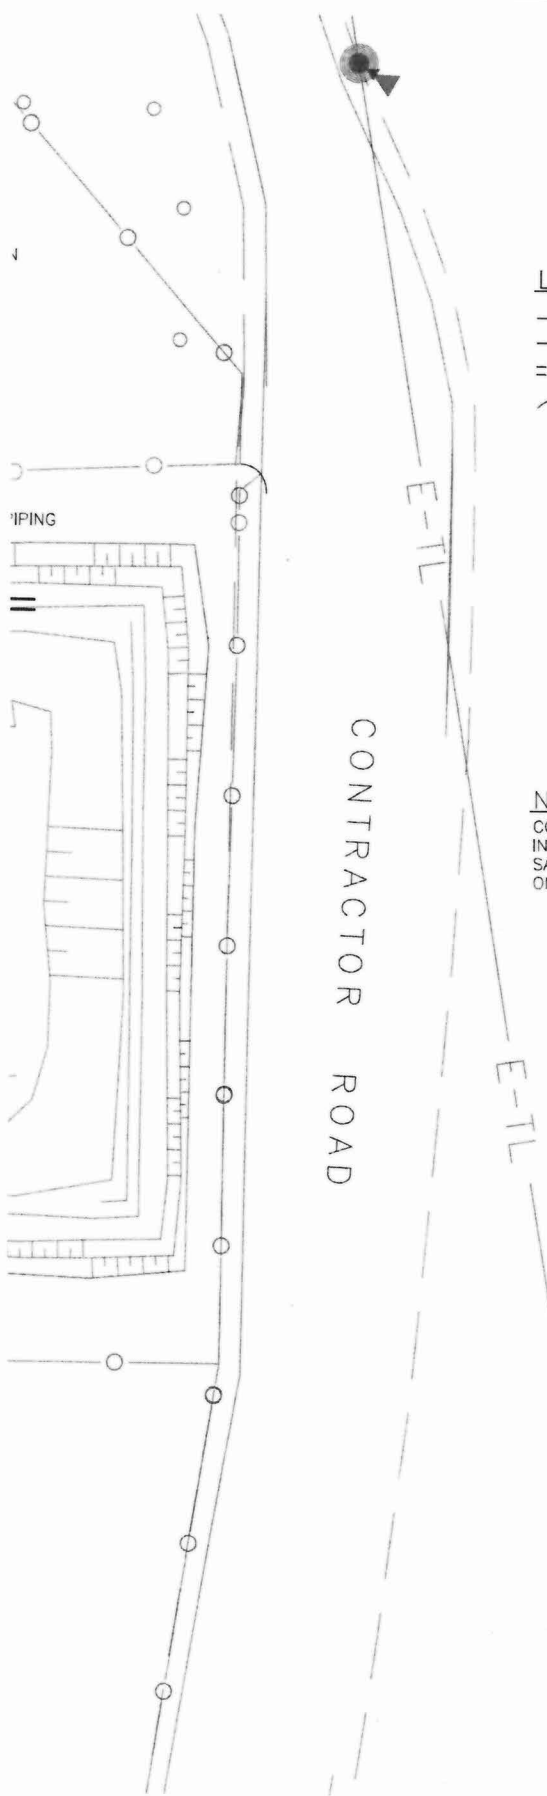
Title: BIOPILE PLAN

CONTRACTOR TO FURNISH AND INSTALL BIOPILE GAS SAMPLING PROBES AS SHOWN ON P-103.

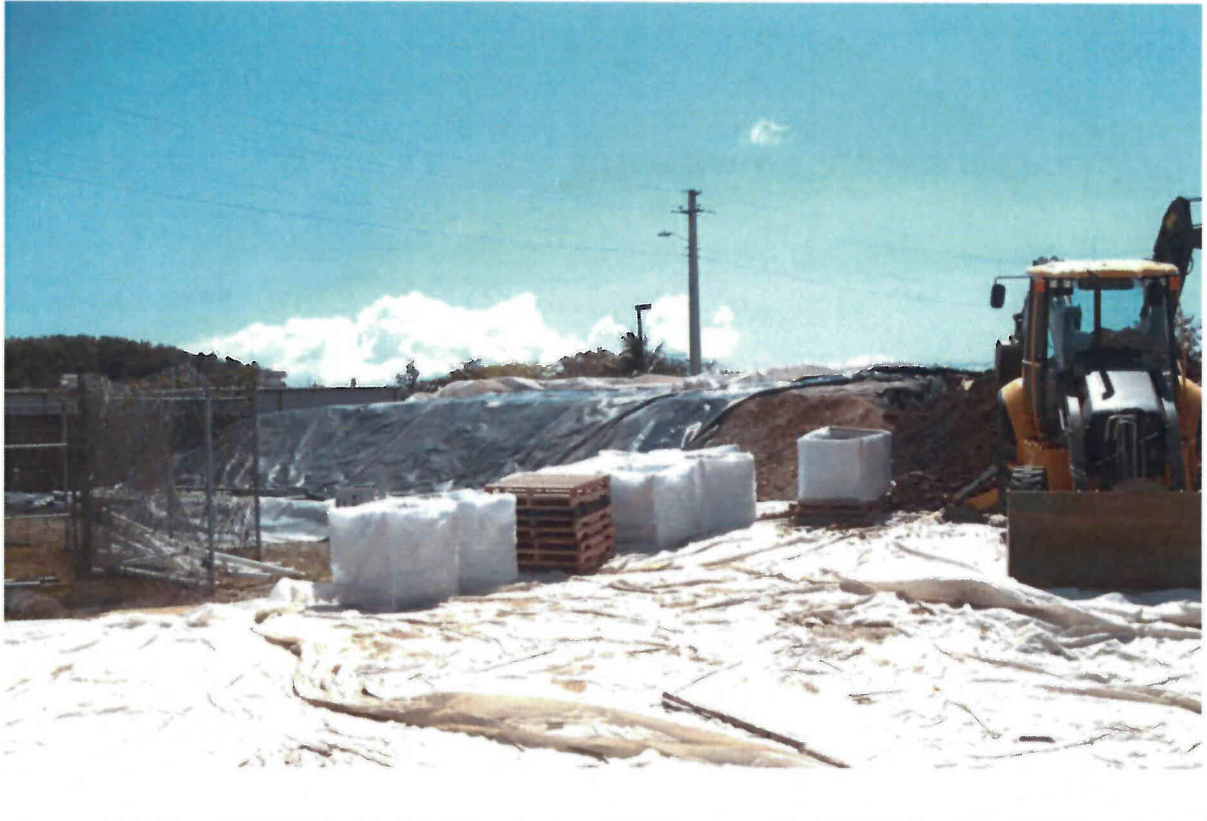
Photo Number: 4

Removal of hazardous soil. Hazardous soil was loaded into lined Flexible Intermediate Bulk Containers (FIBCs). Photograph taken from the north side of the Biopile Project area looking toward the southeast corner of the Biopile.

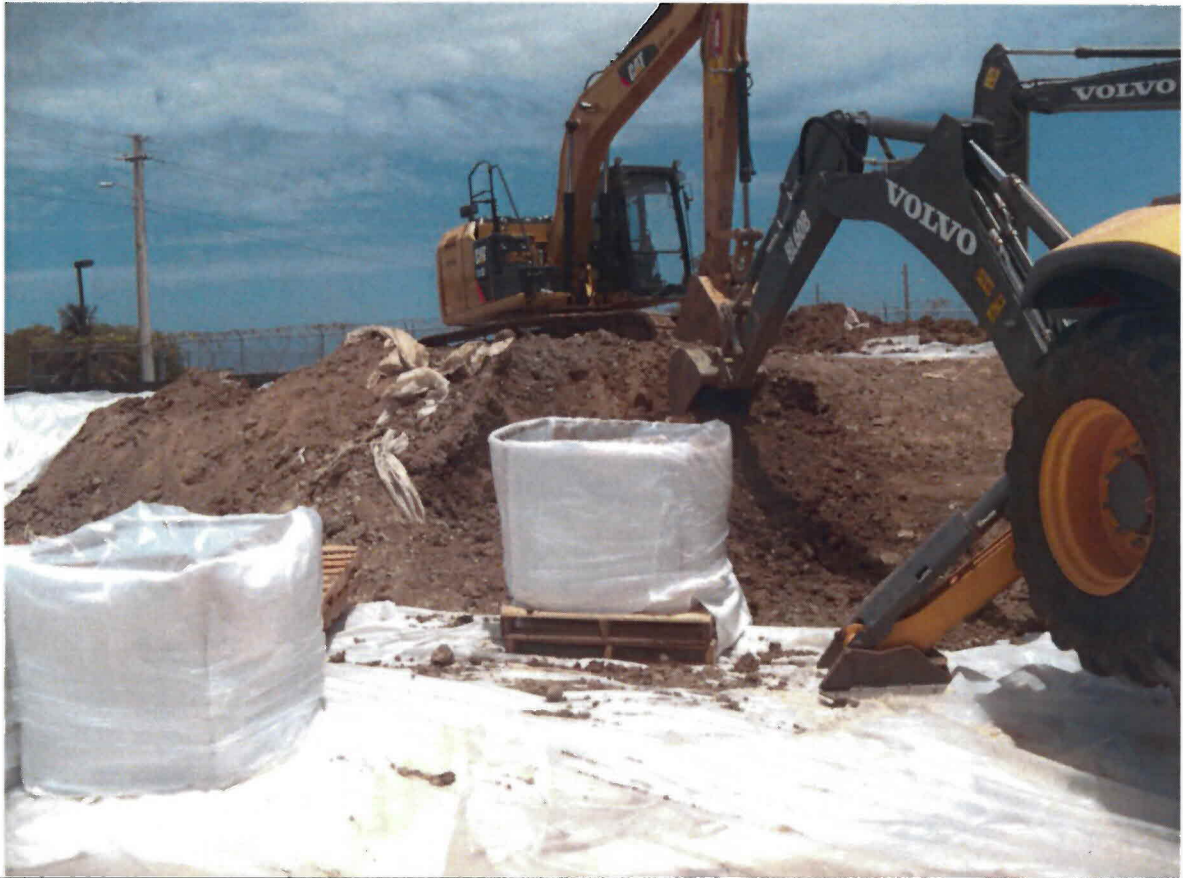
Photo Number: 5

Removal of hazardous soil. Hazardous soil was loaded into lined FIBCs.  
Photograph taken from north side of the Biopile Project Area looking toward the south side of the Biopile.

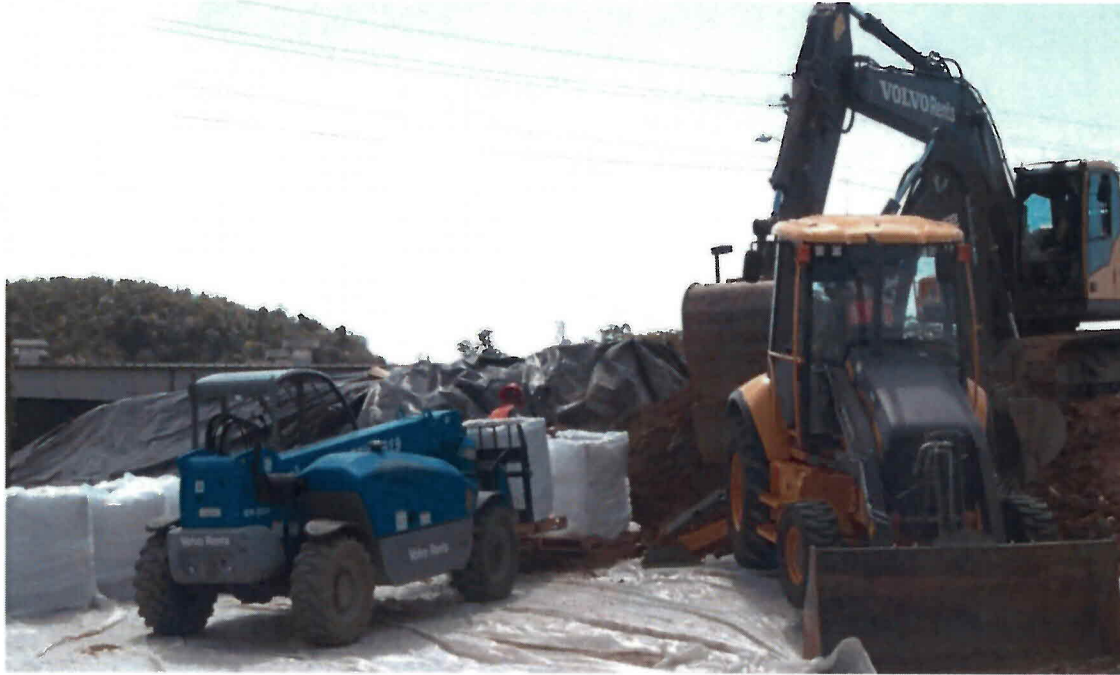
Photo Number: 7

Biopile hazardous soil removal. Hazardous soil was loaded into lined FIBCs by the backhoe and the FIBCs were managed within the Biopile Project Area using a GENIE GTH-5519 forklift. Photograph taken from the north side of the Biopile Project Area looking toward the southeast corner of the Biopile.
